# Rothley Park Golf Club

Report on the golf course incorporating  
programme performance testing

Report date: 27<sup>th</sup> July 2023

Visit objective: To provide an agronomic review of the golf course, collect objective greens performance data and make recommendations for ongoing improvement.

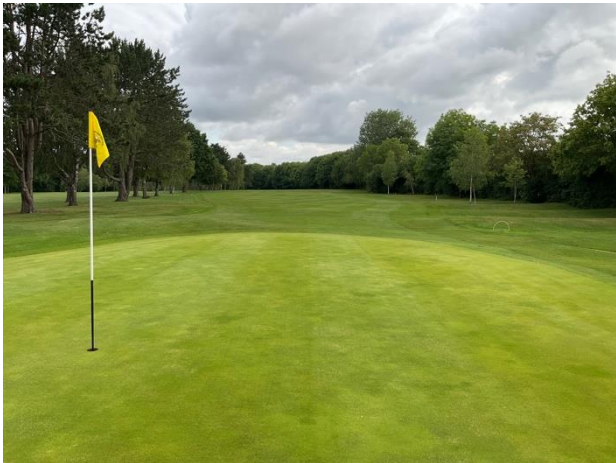
Photo 1: General presentation of the golf course was very good under the stewardship of new Course Manager, Chris Weir.

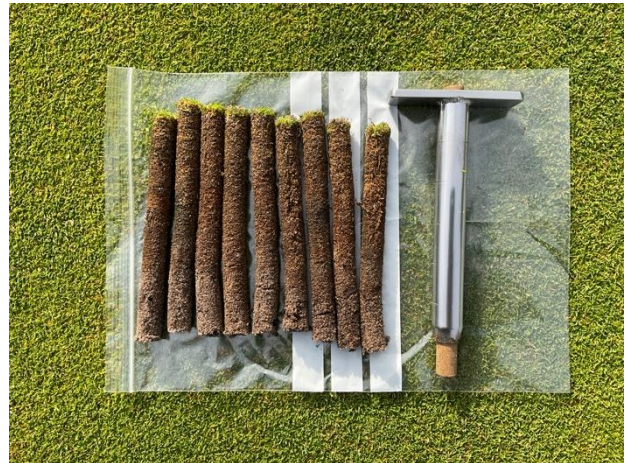
Photo 2: Soil samples collected on the 14<sup>th</sup> Green shows improving sand integration in the upper profile, but the persistence of thatch.

- Laboratory analysis has shown that organic matter accumulation is high in the top 20mm of the soil profile on greens, with an average of 8% identified against a suggested target range of between 3-6%. Organic matter management operations should be targeted at significant material exchange in this zone (i.e., thatch removal for the integration of heavy sand top-dressing).

- Greens renovation week, scheduled for the first week of August 2023, will constitute a pedestrian Graden scarification operation using a 2mm wide blade, appropriately tested for depth to target the problematic zones identified above by the laboratory results. The subsequent delivery of between 35 and 45 tonnes of sand top dressing will be integrated into the profile through the use of a deep solid tine aeration (i.e., Verti-Drain) via outside contractor utilising a 12mm diameter tine to suggested depth of around 120mm. Localised overseeding will be targeted at weaker areas on individual greens as required using the preferred seed mix of choice R9 (Rigby Taylor).

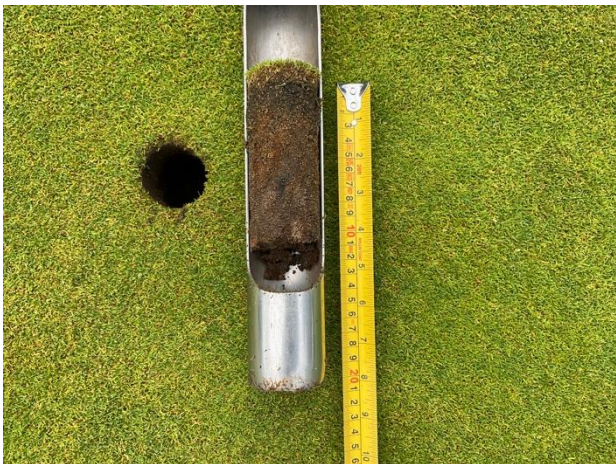
Photo 3: The challenging 7<sup>th</sup> Green, shows the negative influence of organic matter accumulation with signs of anaerobic activity.

- The well reported challenges regarding the growing environment for the 7<sup>th</sup> green continues to have an impact the playing surface which bears localised signs of algal build up in the sward and reported issues of disease activity and moss ingress in the most sheltered areas of the green. Inspection of the soil profile highlights an increased level of organic matter accumulation and some signs of anaerobic activity and as previously suggested a bespoke programme of additional aeration, sanding and overseeding in conjunction with more aggressive thatch removal operations will be key to improving the overall performance of the profile and subsequently the putting surface.

- A more aggressive programme of renovations will be appropriate for the problematic 7<sup>th</sup> green to affect greater material exchange with thatch removal and replacement with sand top dressing and appropriate localised overseeding using the selected Rigby Taylor R9 seed mix.

- As indicated above, the unique nature of the 7<sup>th</sup> green with regards to its growing environment and the impact on thatch accumulation warrants a more aggressive approach to material exchange with the removal of problematic thatch for the introduction of high volumes of sand dressing. To this end, it was suggested that supplementary passes with the Graden scarification unit will be required, and it is likely that this will warrant the application of further, heavy sand top-dressing and a comprehensive overseeding programme.

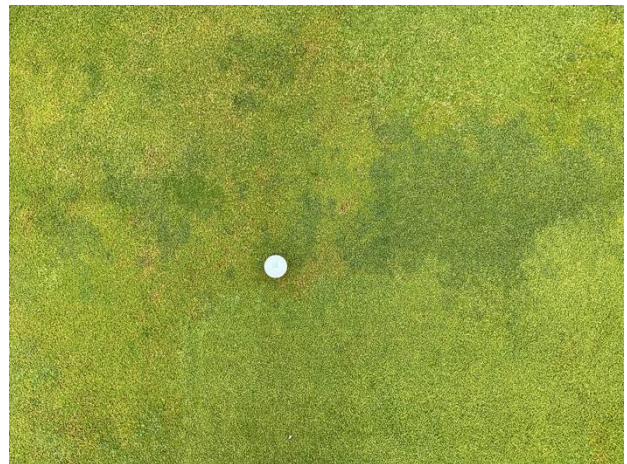
Photo 4: The component grasses on the 14<sup>th</sup> Green are starkly different in appearance, but not deemed to be having a negative impact on performance.

- The putting surfaces are generally well-presented and even those that display significant proportions of differing grass types (i.e., 14<sup>th</sup> green which remain visually very obvious) display very good performance characteristics on the greens.

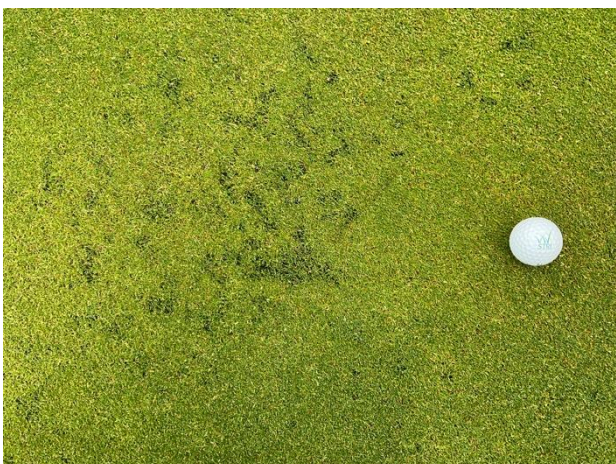
Photo 5: Algal build-up is apparent in localised areas at the rear of the 7<sup>th</sup> Green, where thatch levels are elevated, and the surface sits wet occasionally.

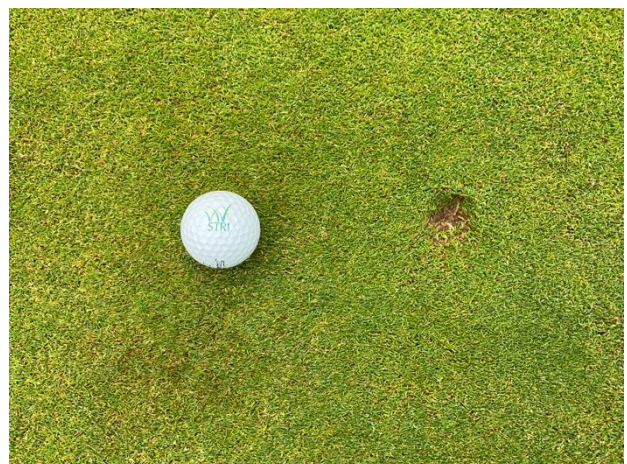
Photo 6: Unfortunately, poorly repaired, or regrettably completely unrepaired pitch marks, represent one of the largest negative impacts on green presentation and performance.

- Regretfully on the day, one of the most prevalent incidences with regards to imperfections on the putting surfaces was the ongoing issue with unrepaired, or poorly repaired, pitch marks.

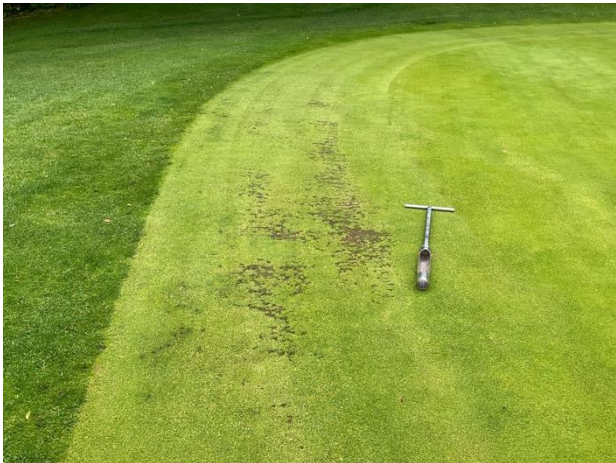
Photo 7: Areas of thinning grass cover are also evident at the rear left-hand side of the sheltered 7<sup>th</sup> Green.

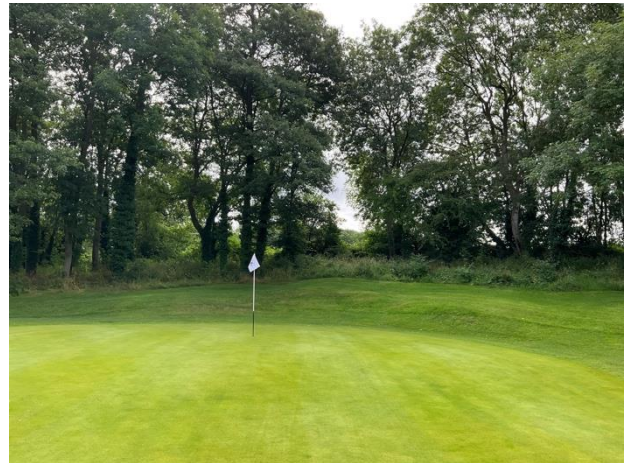
Photo 8: Surrounding woodland is a key factor in the restricted growing environment at the 7<sup>th</sup> Green.

- On the day the regularly discussed issues regarding the woodland around the 7<sup>th</sup> green were once again addressed with the suggestion, where possible, to remove underlying growth, and certain specimens to open pockets of light and air through to the struggling putting surface.

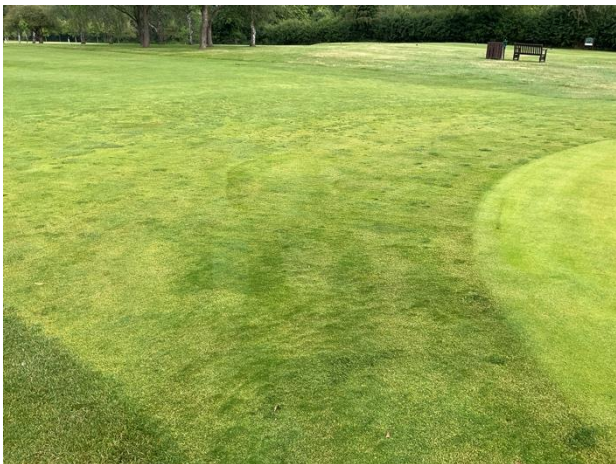
Photo 9: The 16<sup>th</sup> green approach is indicative of these key areas across the site, which are largely neat but need refinement of the grass cover.

- Despite being relatively neat and tidy, differential growth between the component grasses within the greens approaches is having a detrimental effect on overall presentation and performance of these key areas. When oppressive weather conditions abate, consider a programme of targeted refinement to alleviate some of the lateral growth and allow the integration of sand top dressing and overseeding to promote a more uniform playing surface.
- Nutritional inputs, targeting greens approaches and the teeing platforms, commenced with an application of Rigby Taylor Convert Gold (15-5-15) in March, a monthly liquid application of Microflow 17-2-5 tank mixed with Primo Maxx growth regulator and Breaker Sport wetting agent monthly between April and August, with a final granular application in September of Convert Gold 16-4-13.

- Continue to promote routine star tine aeration on the greens, tees and approaches using the pedestrian Toro Procore 648.
- Once hot and dry oppressive conditions ease, but growth conditions remain strong, undertake a programme of refinement operations on the greens approaches to target procumbent growth, promote an upright growth pattern and incorporate sand top-dressing and seed to deliver a more uniform grass coverage and a smoother transition from fairway to green.

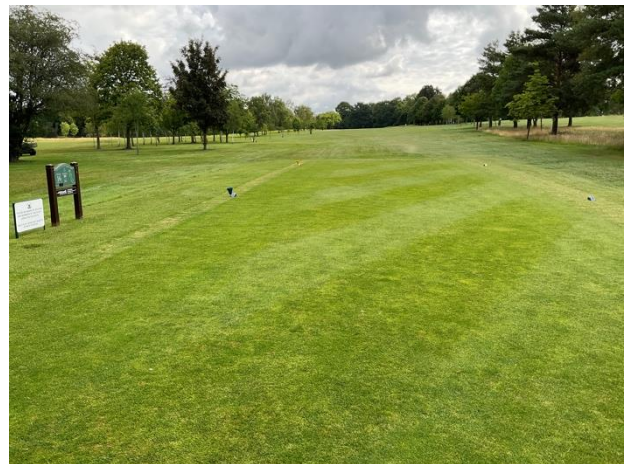
Photo 10: The teeing platforms are very well presented and continue to deliver good teeing area and sound levels (see 16<sup>th</sup> Tee above).

- Tees continue to deliver good teeing area and sound surface levels and are well-presented at the current 12mm height of cut.

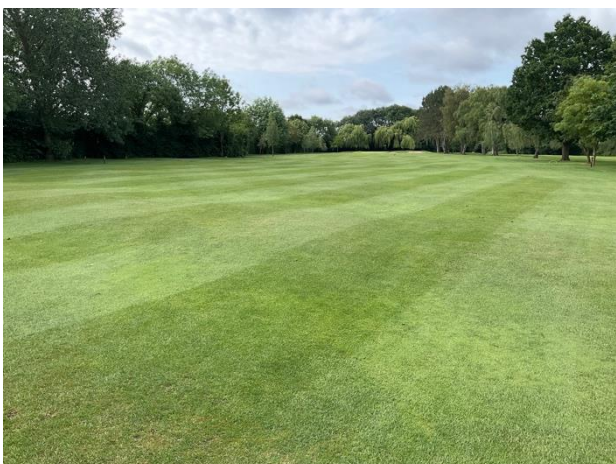
Photo 11: Fairways have recovered very well from the oppressive weather conditions of recent summers.

- Fairways are very neat and tidy and appear to have recovered extremely well from the oppressive drought pressures of recent summers.
- Current height of cut is around 16mm, and it is suggested that a marginal increase to approximately 18mm may be appropriate if prolonged periods of hot and dry weather persist.
- It was suggested that nutritional inputs are confined to an application of 25:0:0 only when required in conjunction with Primo Maxx plant growth regulator to promote a denser lateral growth pattern, favoured over vertical, leafy growth.
- More uniform presentation of fairways is apparent in comparison to previous years when the typical ridge and furrow topography in places caused extremes of droughting pressures on the raised areas.

- Consider a marginal increase in the height of cut on fairways to 18mm during oppressive weather conditions in the summer to alleviate the drought stresses on the grass plant.

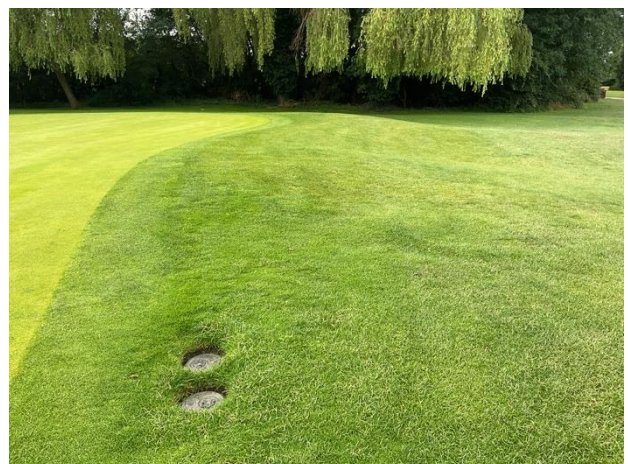
Photo 12: Selected areas of the green surrounds provide significant scope for development as areas of fine turf run-off.

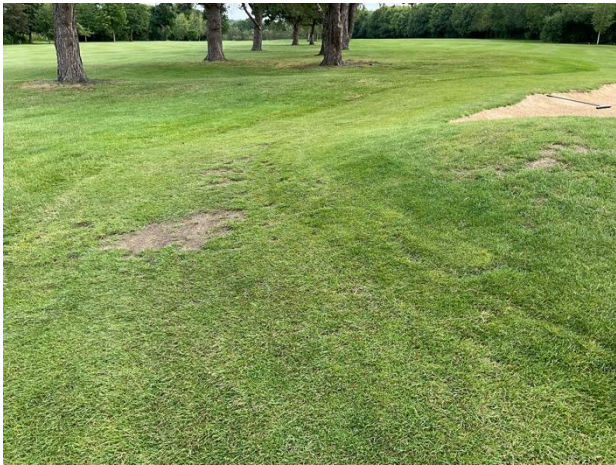
Photo 13: Some more exposed, or heavily trafficked areas, around the green complexes require localised repairs to improve grass cover.

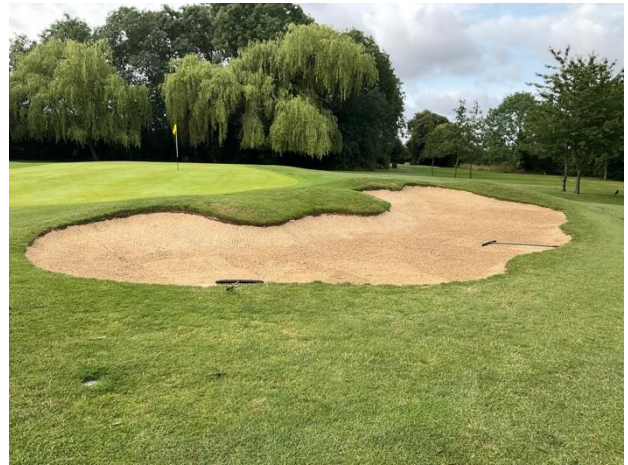
Photo 14: Recent bunker works have yielded very positive results across the site and remain well-presented and are performing well.

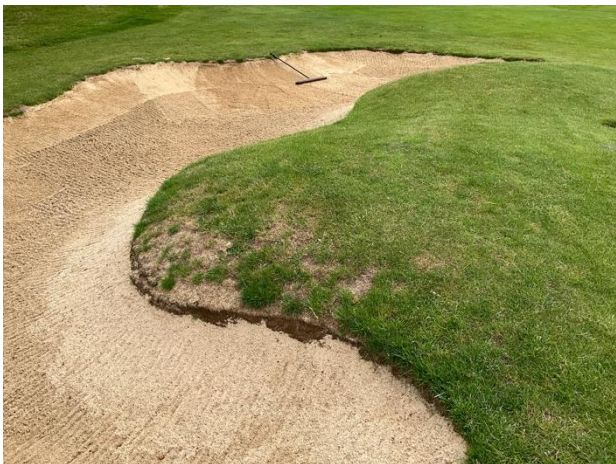
Photo 15: As identified previously, bunker noses and the more exposed mounding has deteriorated under hot and dry conditions.

- The general overhaul of the sand hazards across the site has delivered good results and a new process with routine maintenance has optimised the presentation and performance of the bunkers across Rothley Park.
- A regime of a “full hand rake” on Monday from the back of the bunker, and the rolling of the faces on a Friday using a squeegee, has helped to optimise presentation and performances of the bunkers consistently.
- Some well-discussed issues remain with regards to the more exposed bunker noses and raised areas of the surrounds which have been negatively impacted by hot and dry weather conditions, and as previously suggested, the aeration of the affected areas for the introduction of a curative granular wetting agent would be appropriate to help restore full grass cover.

- Address drought damage on bunker noses and exposed mounding, as previously suggested, by employing localised aeration and the delivery of a granular curative wetting agent (i.e., Aquatrols Aqueduct Flex Granular, or similar).

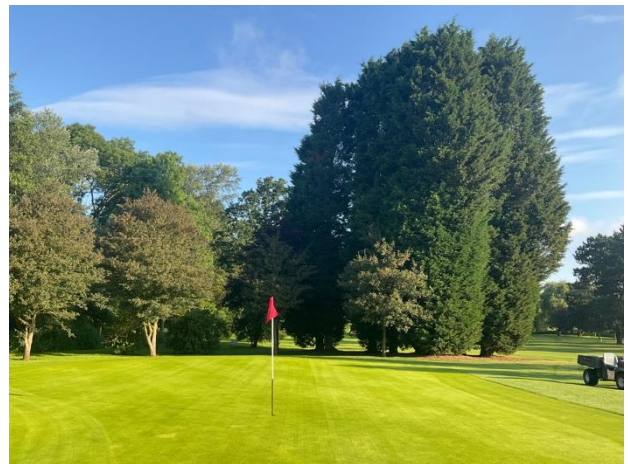
Photo 16: The large poplars at the rear of the 15<sup>th</sup> Green are having a significant, negative impact on air circulation and light penetration to the green.

- In particular, the negative influence of the willow trees around the site was discussed generally and more specifically the dense poplars at the rear of the 15<sup>th</sup> green having a significant negative impact on light penetration and air circulation to the adjacent green. It is suggested that an outside specialist contractor be engaged to physically remove a large number of the trees to improve the growing environment.

- Engage a reputable woodland management company to undertake an audit of the site to provide continuity when the 2018 audit expires this year. Promote ongoing works, focused on woodland areas which are having a negative impact on key playing surfaces (i.e., greens & tees), commencing with the partial removal of some poplars at the rear of the 15<sup>th</sup> green.

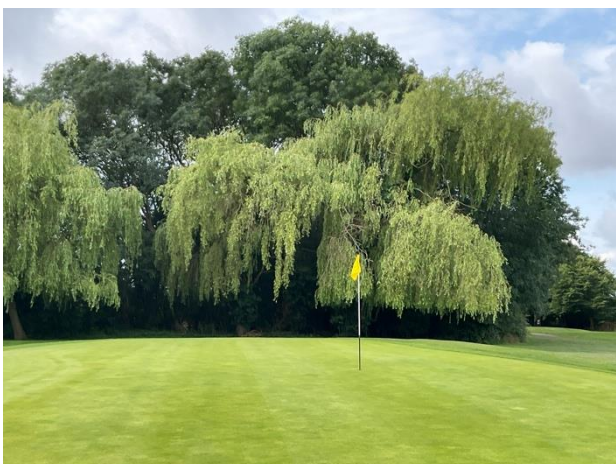
Photo 17: Similarly, willow trees across the site present an ongoing challenge to adjacent surfaces due to dense foliage and expanding root networks.

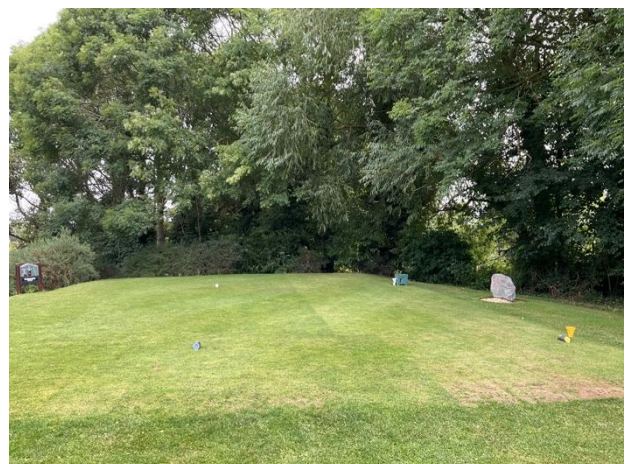
Photo 18: The sheltered nature of the 8<sup>th</sup> competition tee, has warranted routine stripping and reurfing of the playing surface.

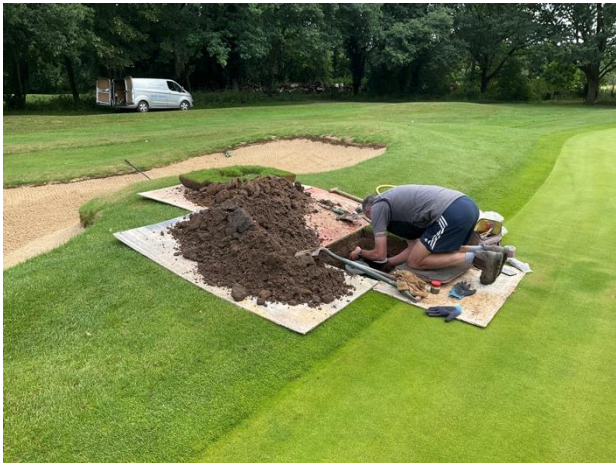
Photo 19: A reputable, outside irrigation contractor has been engaged to undertake key repairs on the sprinkler network.

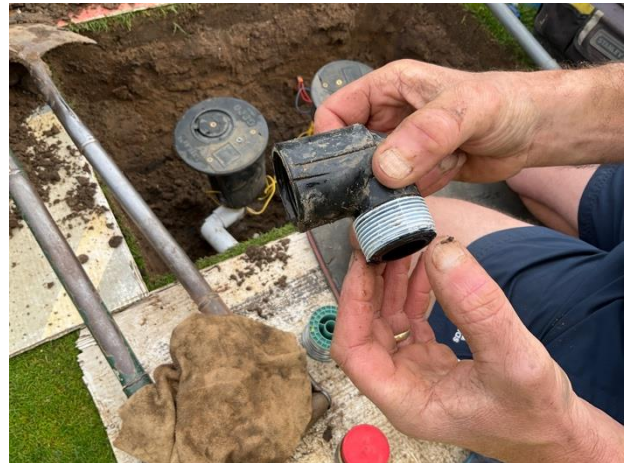
Photo 20: Problems have arisen due to the use of inappropriate connections on green side sprinkler pipework, which have subsequently failed.

- Some targeted irrigation upgrades were being carried out on the day of the visit, via outside contractor, around green side irrigation provision in order to tackle some of the issues faced with failures in the pipework thought to be as a result of the wrong fittings being used.

- Continue with positive targeted repairs of irrigation around greens complexes to address problematic connections to the pipework and investigate long-term water supply security and the provision for adequate storage on site to service all irrigation requirements.

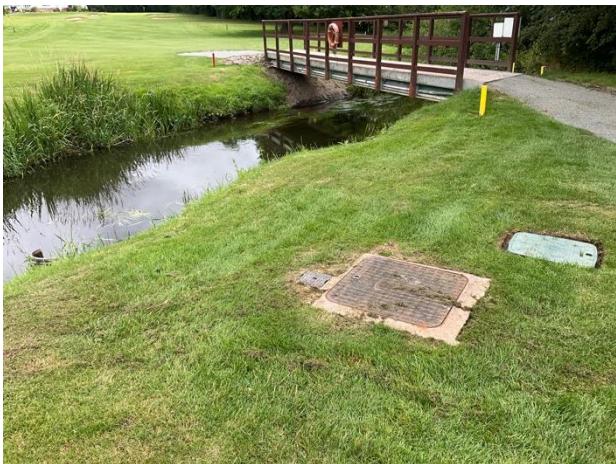
Photo 21: River abstraction, passed through a filtration system, is key to irrigation water supply at a reported 3000m<sup>3</sup> per month.

- With river abstraction being reportedly 3000m<sup>3</sup> per month, there appears to be an adequate supply to service irrigation requirements, but it should be noted that if the pressure drops significantly in the village than the abstraction licence is restricted. With an inevitable switch to mains water supply in the event of this scenario, the limitations of the onsite storage capacity are highlighted. Reportedly, current storage tanks hold a total of 90 cubic metres and the optimum requirement is for some 300m<sup>3</sup> of storage capacity to optimise water security when river abstraction is unimpeded and thereby negate the necessity to look towards mains water supply to supplement the system.

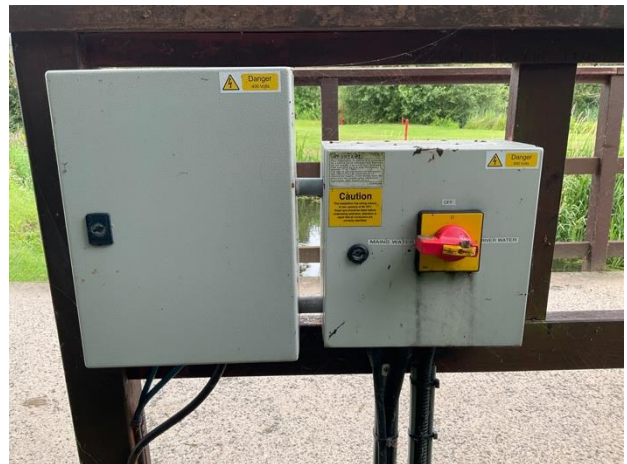
Photo 22: Switch controls, on the right of the above image, directs water supply from the river abstraction to mains when required.
